ARIZONA DEPARTMENT OF TRANSPORTATION USES SNAP-TITE FOR CULVERT REHABILITATION

Abstract

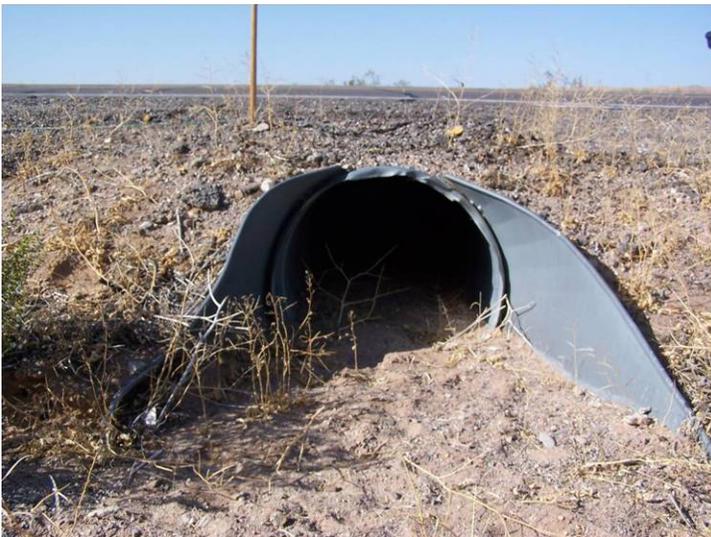
The outside of the culvert to be rehabilitated.

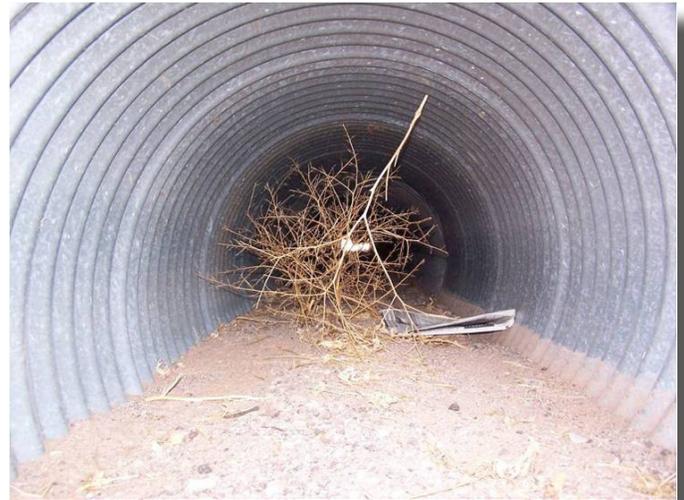
With 8" – 10" of sediment inside the 30" CMP, the culvert had to be cleaned prior to installation of 24" Snap-Tite pipe.

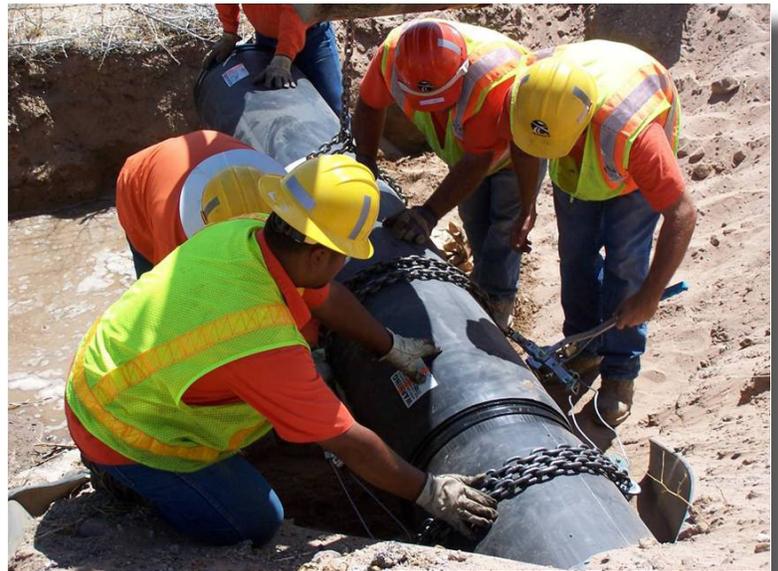
The Snap-Tite pieces mechanically connect with chains & come-a-longs.

The Snap-Tite lining system is joined together with a machined joint on the ends of the pipe with the inclusion of a gasket. It is simply snapped together. The resulting joint is water-tight with an inside and outside diameter the same as that of the pipe. This means there will be no flow restrictions or coupling hang-ups during the installation process.

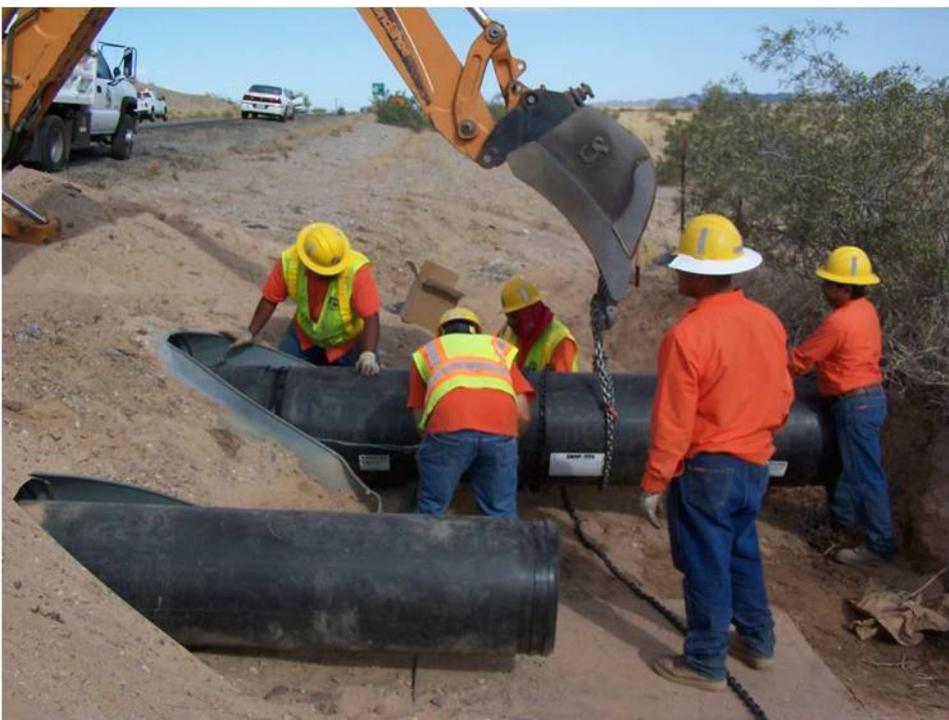
Equipment used to align pipe.
